# ELECTRICAL DIAGNOSTIC INVESTIGATION REPORT

Measured engineering evidence for a modern city-centre extended-stay apartment hotel

ANONYMISED SAMPLE REPORT Commercial property | United Kingdom

Independent Electrical Diagnostic Survey

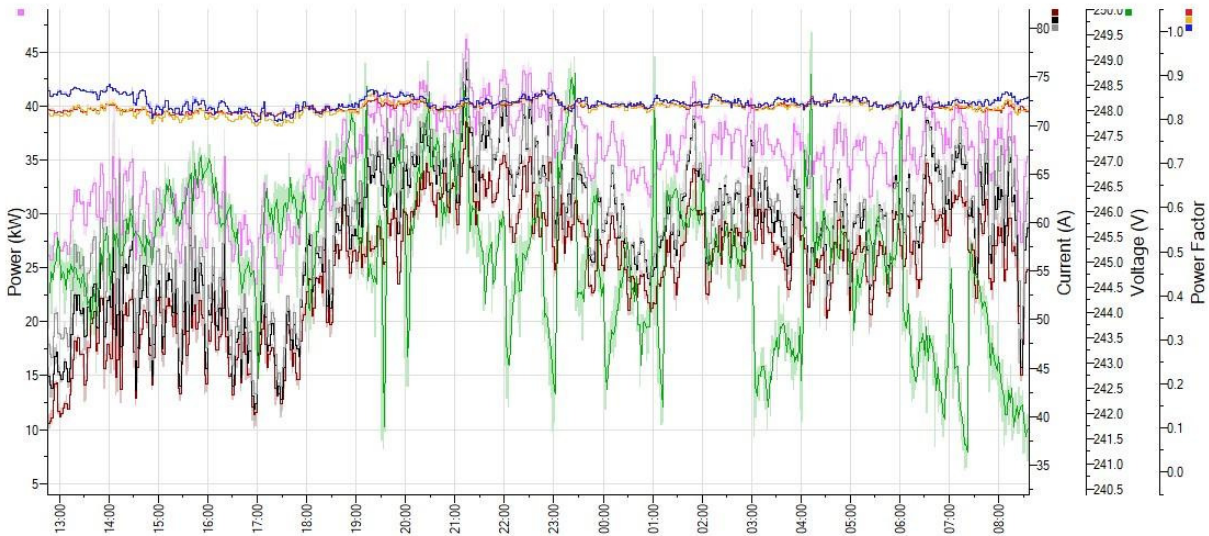
Figure 1 - Basement plant-room electrical profile. Estimated annual carbon: 76.26 tonnes.

Demand varied continually, reducing overnight before increasing with building activity. No prolonged fixed load was identified. Power factor remained generally stable and the supply voltage showed no significant abnormality. The profile is consistent with properly controlled plant responding to operational demand.

ENGINEERING CONCLUSION Status: Operating as expected. Recommendation: No corrective action is recommended.

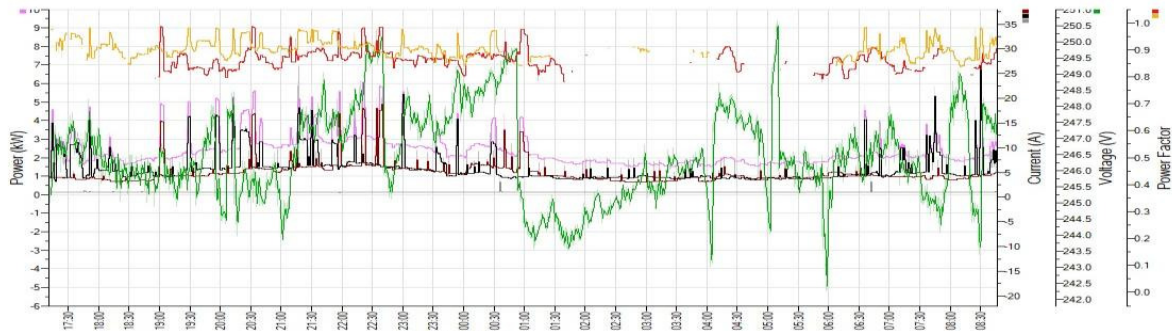
Figure 2 - Representative ten-room distribution board, Floor 8. Estimated annual carbon: 5.23 tonnes.

Demand reduced significantly during periods of low occupancy and increased naturally as guest activity resumed. This pattern was consistent across the representative floors, despite permanently connected refrigeration and cooking appliances in each suite.

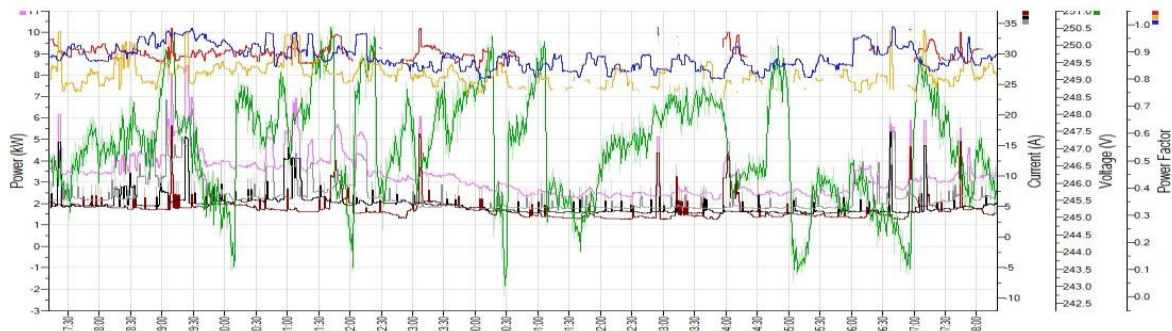
Figure 3 - Representative ten-room distribution board, Floor 6. Estimated annual carbon: 7.38 tonnes.

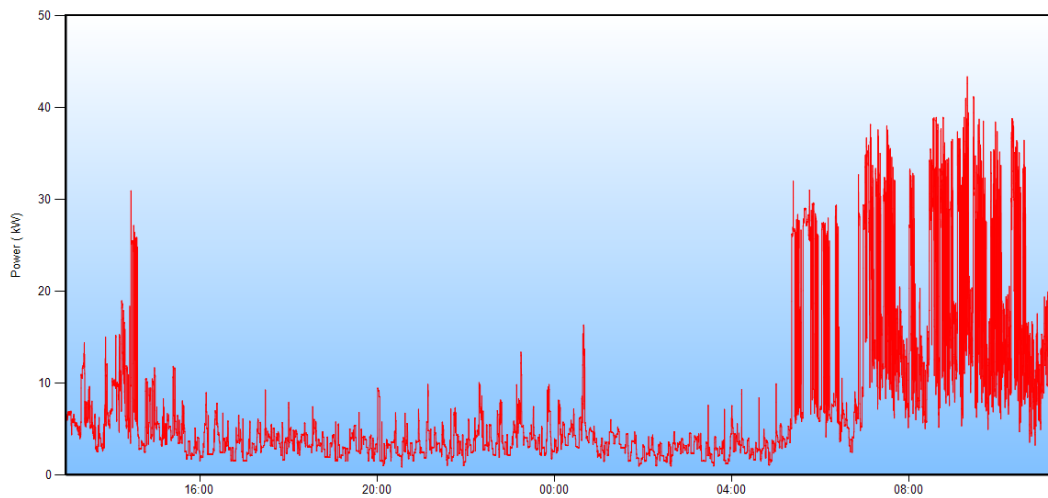
Figure 4 - Kitchen distribution-board electrical profile.

The low overnight demand, marked increase during breakfast preparation and variable daytime load are consistent with normal commercial-kitchen operation. No significant uncontrolled base load or unnecessary continuous operation was identified.

ENGINEERING CONCLUSION Status: Operating as expected. Recommendation: No corrective action is recommended.

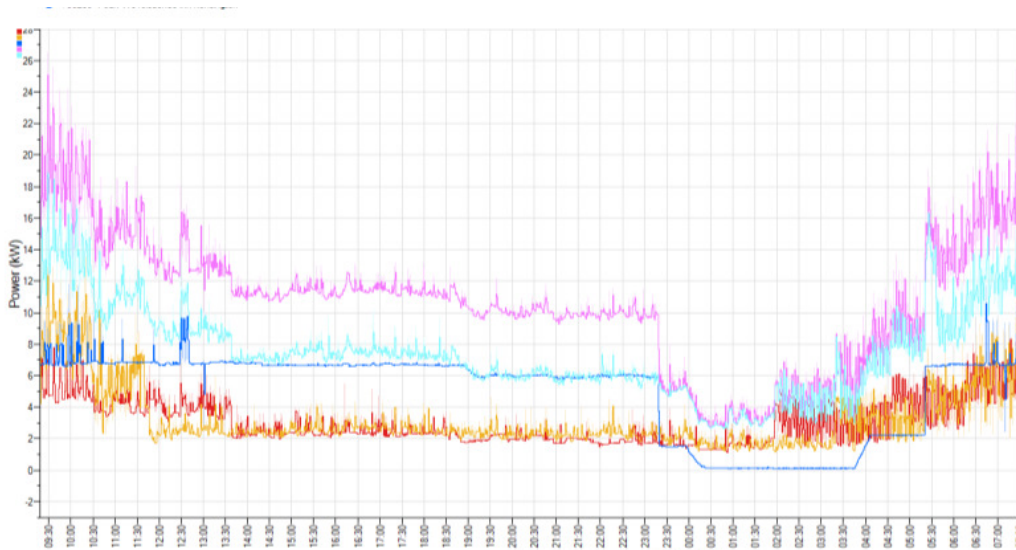
Figure 5 - Reception and public-areas electrical profile.

Demand reduced clearly overnight and increased gradually from early morning as reception, lighting and associated public-area services returned to normal operation.

ENGINEERING CONCLUSION Status: Operating as expected. Recommendation: No corrective action is recommended.

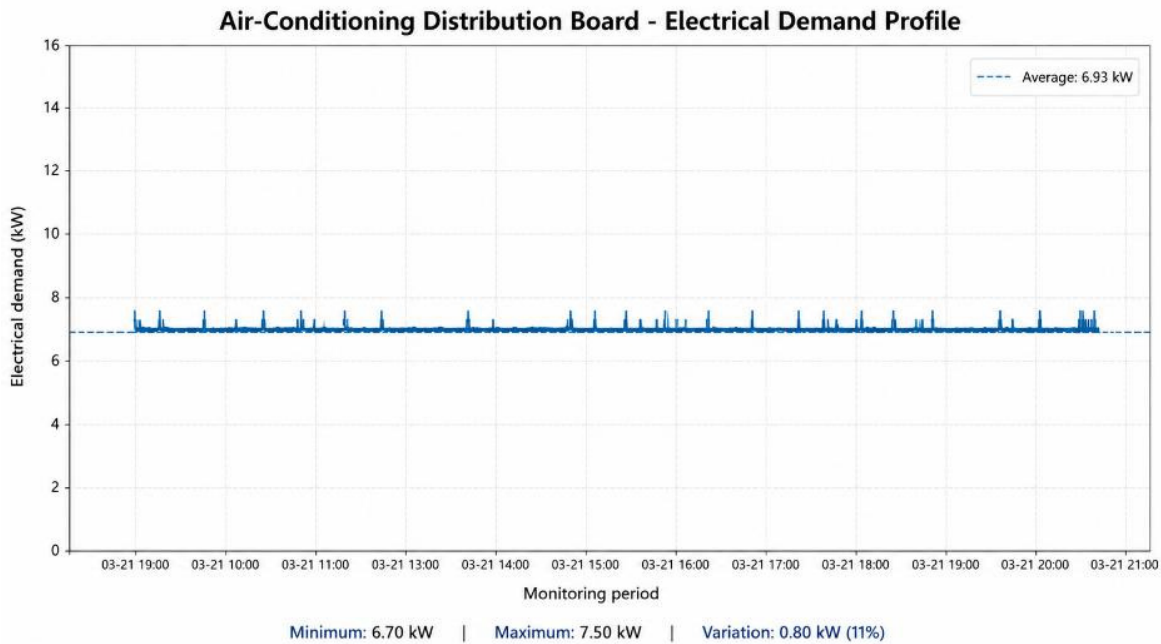
Figure 6 - Air-conditioning distribution-board profile showing an almost constant load close to 7 kW.

The recorded demand remained almost constant throughout the monitoring period, with only minor variation despite changes in occupancy, ambient conditions and expected cooling demand.

The maintenance team advised that an associated condenser had failed and was awaiting repair. The profile is consistent with a fan continuing to operate in response to an unmet cooling demand. Because the setpoint could not be satisfied, the fan continued circulating unconditioned air while consuming electrical power but delivering little or no useful cooling.

**MEASURED DIAGNOSIS** One air-conditioning section continued consuming approximately 7 kW while delivering little or no useful cooling.

STATUS: ENGINEERING ATTENTION REQUIRED The monitored profile is inconsistent with a correctly functioning air-conditioning system. The measured evidence and information obtained during the site inspection point to continued fan operation associated with a failed condenser.

- Isolate the affected fan or fans associated with the failed condenser to prevent further unnecessary consumption.
- Complete the planned repair or replacement of the failed condenser.
- Recommission the affected system and verify that electrical demand again varies with changing cooling demand.

Following repair and recommissioning, repeat electrical monitoring should confirm that the affected air-conditioning demand varies in response to changing cooling requirements rather than remaining close to 7 kW continuously.
